MEMORANDUM

To:	Valmichael Leos and Anne Foster U.S. Environmental Protection Agency	Date:	May 4, 2015
From:	John Laplante, John Verduin, Wendell Mears, and David Keith, Anchor QEA	Project:	090557-01
Cc:	Gary Miller, USEPA Philip Slowiak, IP David Moreira, MIMC		
Re:	Post-TCRA Semi-Annual Inspection Report – January/April 2015 Inspection

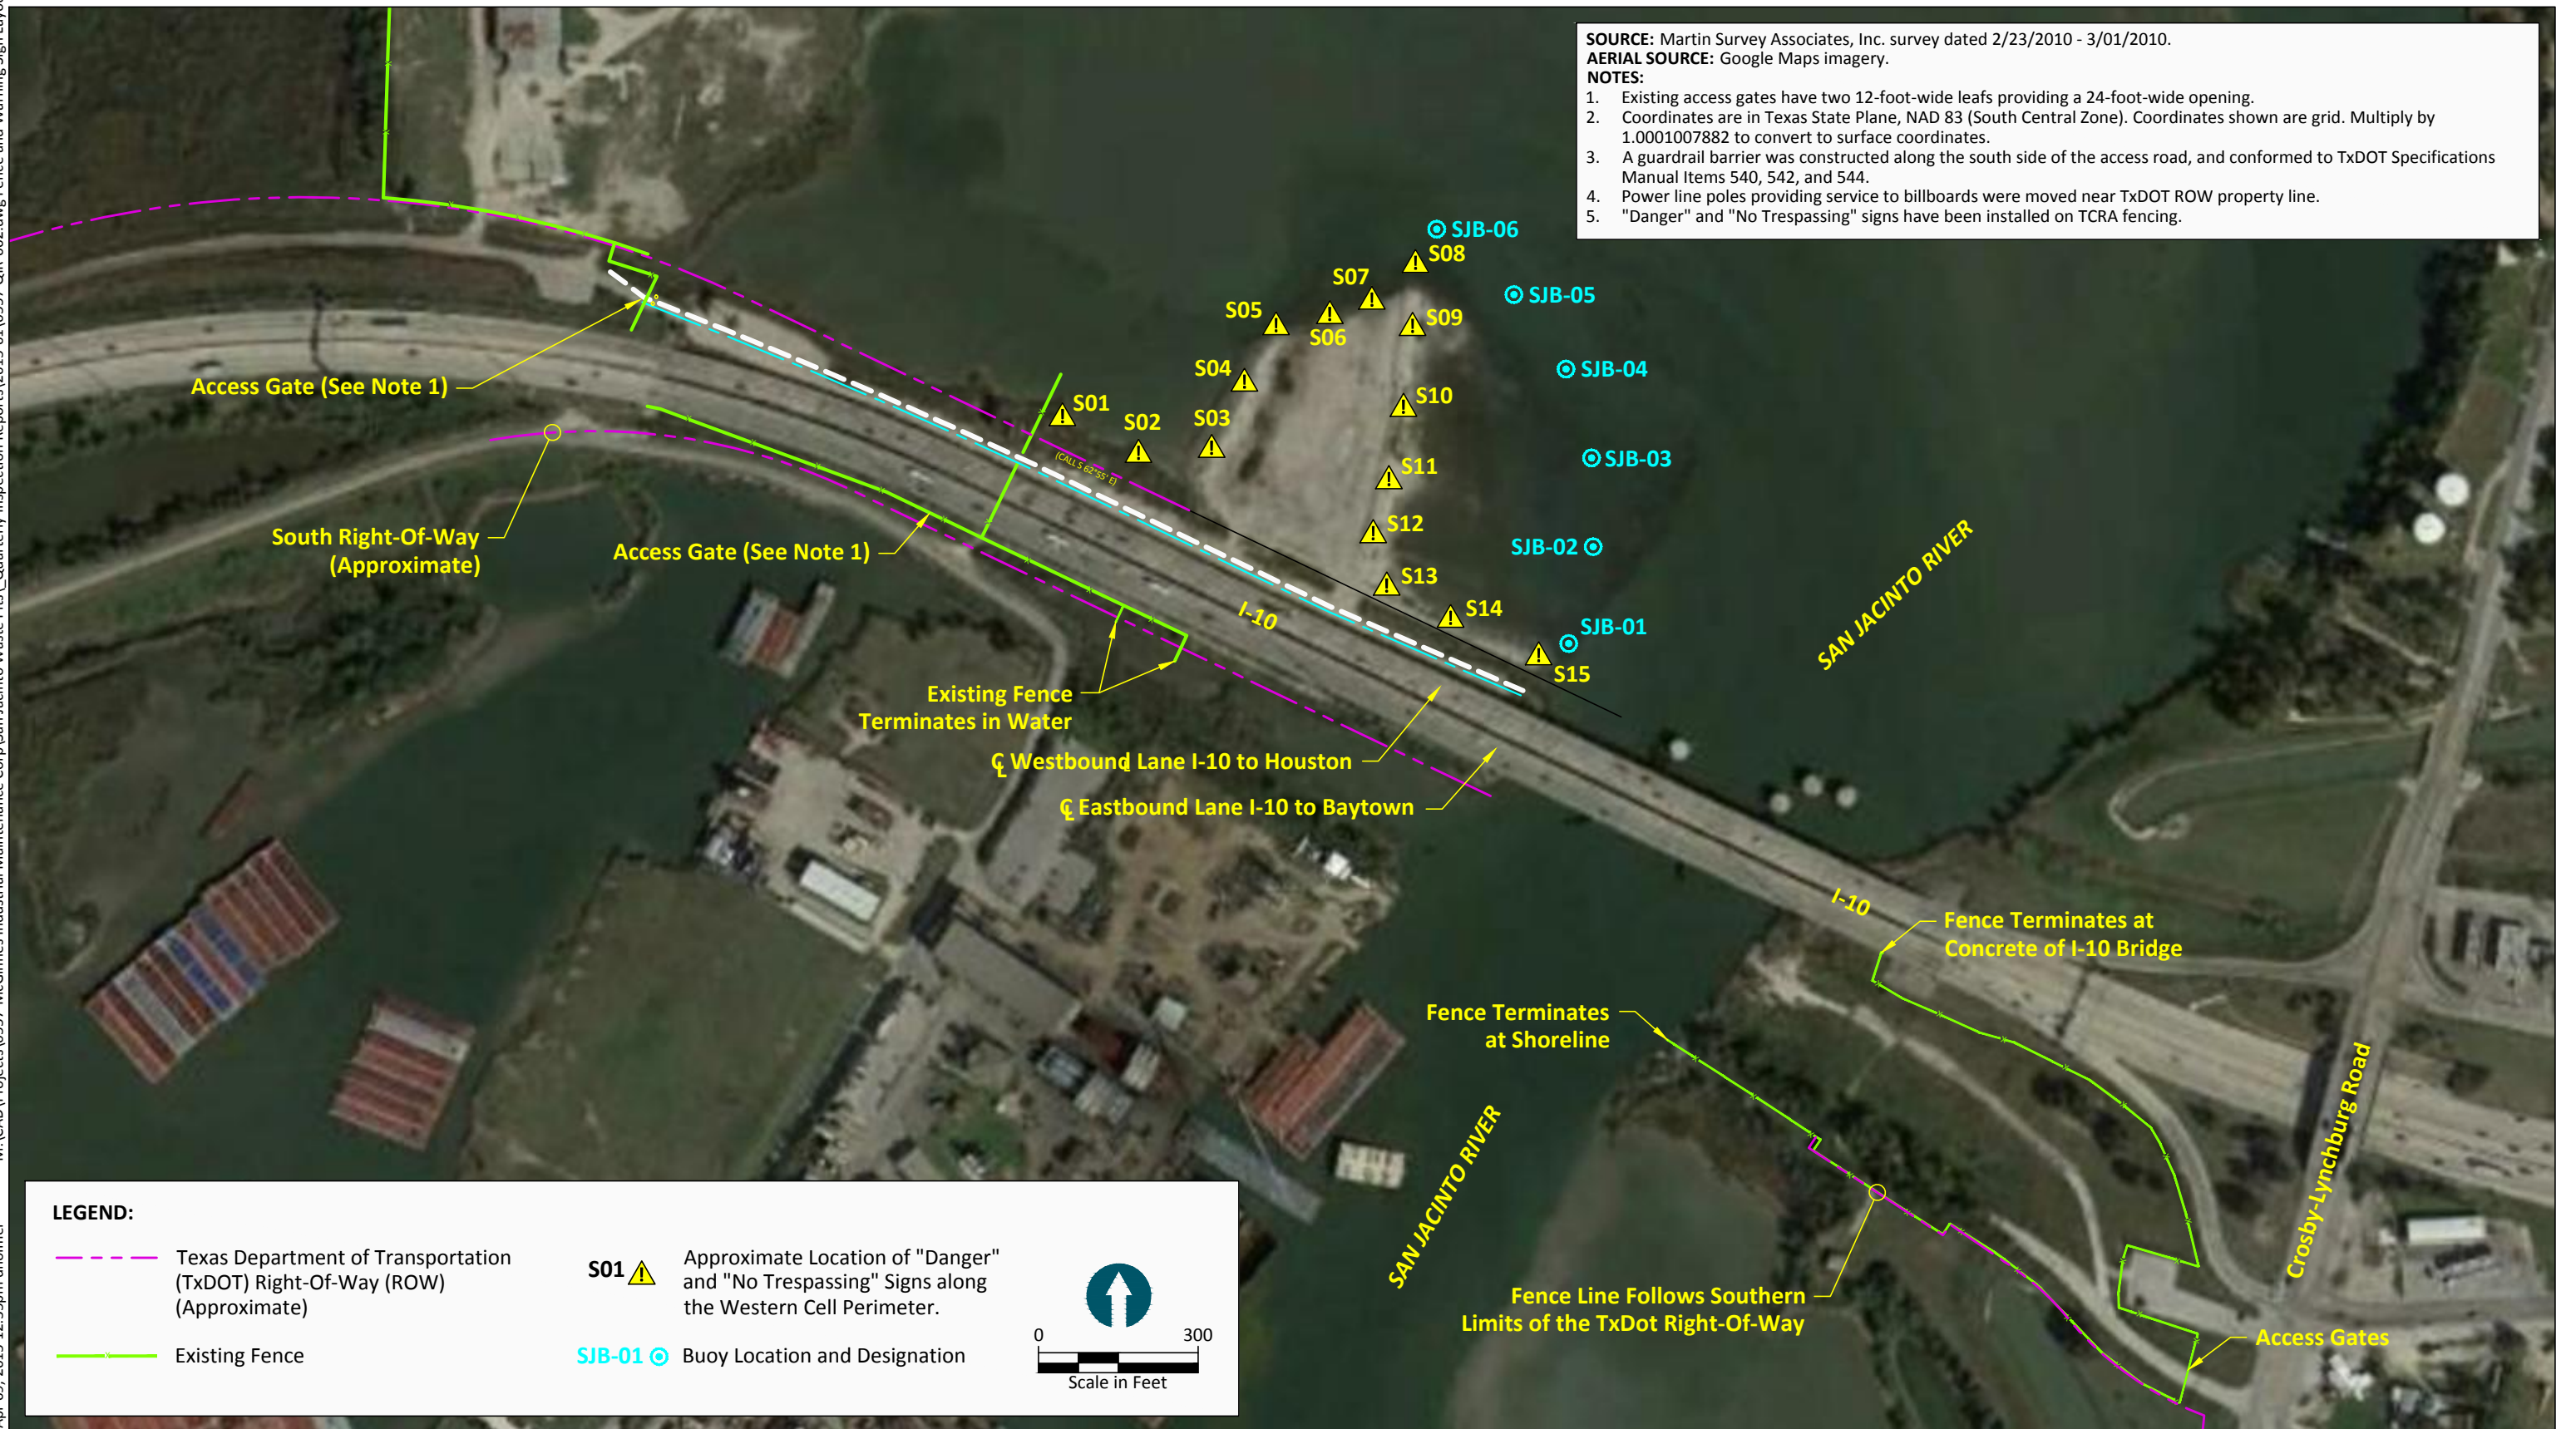
M:\CAD\Projects\0557-McGinnes Industrial Maintenance Corp\San Jacinto Waste Pits\Quarterly Inspection Reports\2015-01\0557-QIR-002.dwg Fence and Warning Sign Layout
Apr 09, 2015 12:35pm dholmer

The perimeter fencing (Figure 2) on the west and east banks of the San Jacinto River was visually inspected for breaches or other signs of damage on January 8, 2015. No breaches or other signs of fence damage were observed during the inspection for any of the three sections of the fence: the east bank, the west bank on the north side of I-10, or the west bank on the south side of I-10. For examples, see Photographs 14 through 18 in Appendix A.

“Danger” and “No Trespassing” signs are posted at regular intervals on the perimeter fencing surrounding the Site. For examples, see Photographs 14 and 16 through 18 in Appendix A. These signs were observed to be in place during the January 8, 2015 inspection.
